Building Number: 626

Area:	West Barracks

Task One: Conditions Assessment***Site Context***

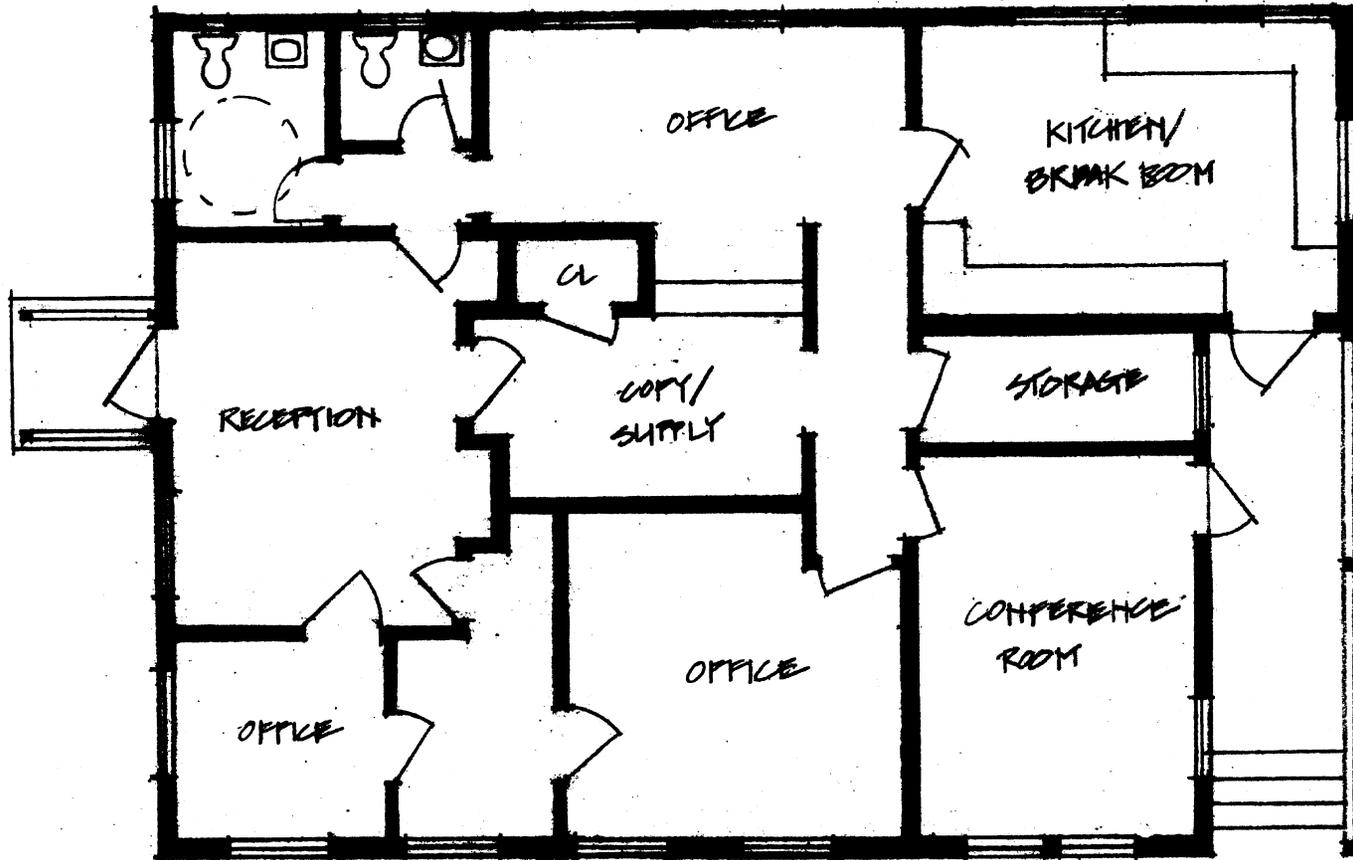
BUILDING 626 OFFICE
SCALE: 1/8" = 1'-0"

NOTE: INTERIOR WALL
CONFIGURATION
CAN BE RETAINED

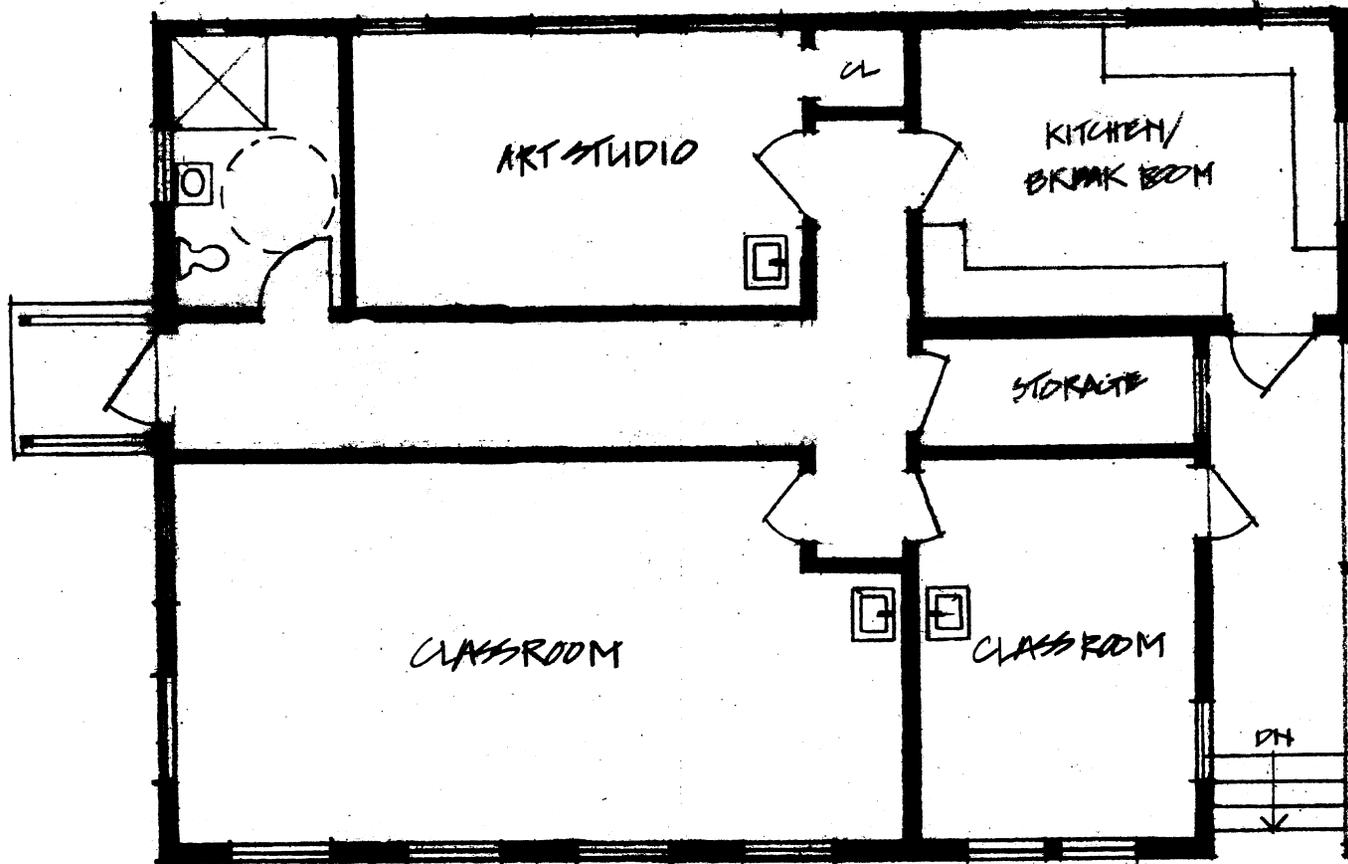
BUILDING 626 EDUCATION ARTS
SCALE: 1/8" = 1'-0"

NOTE: INTERIOR WALL
CONFIGURATION
ALTERED DRASTICALLY
